K & A Engineering, Inc.  
3327 Roanoke Ave., Eugene, OR 97408  
(541) 684-9399 Voice  
(541) 684-9358 FAX

Project: 145.06

Subject: Response to City of Eugene staff report 8/14/2006  
Geotechnical issues for proposed Dillard Heights P.U.D.  
Dillard Road, Eugene, Oregon

**DILLARD HEIGHTS P. U. D.**  
**GEOTECHNICAL SITE PLAN**  
**DILLARD ROAD, EUGENE, OREGON**  
 CLIENT: SNOOK MOUNTAIN RESOURCES  
 PROJECT: 146.00  
 DATE: 4/23/2006  
 SHEET: 1 OF 1

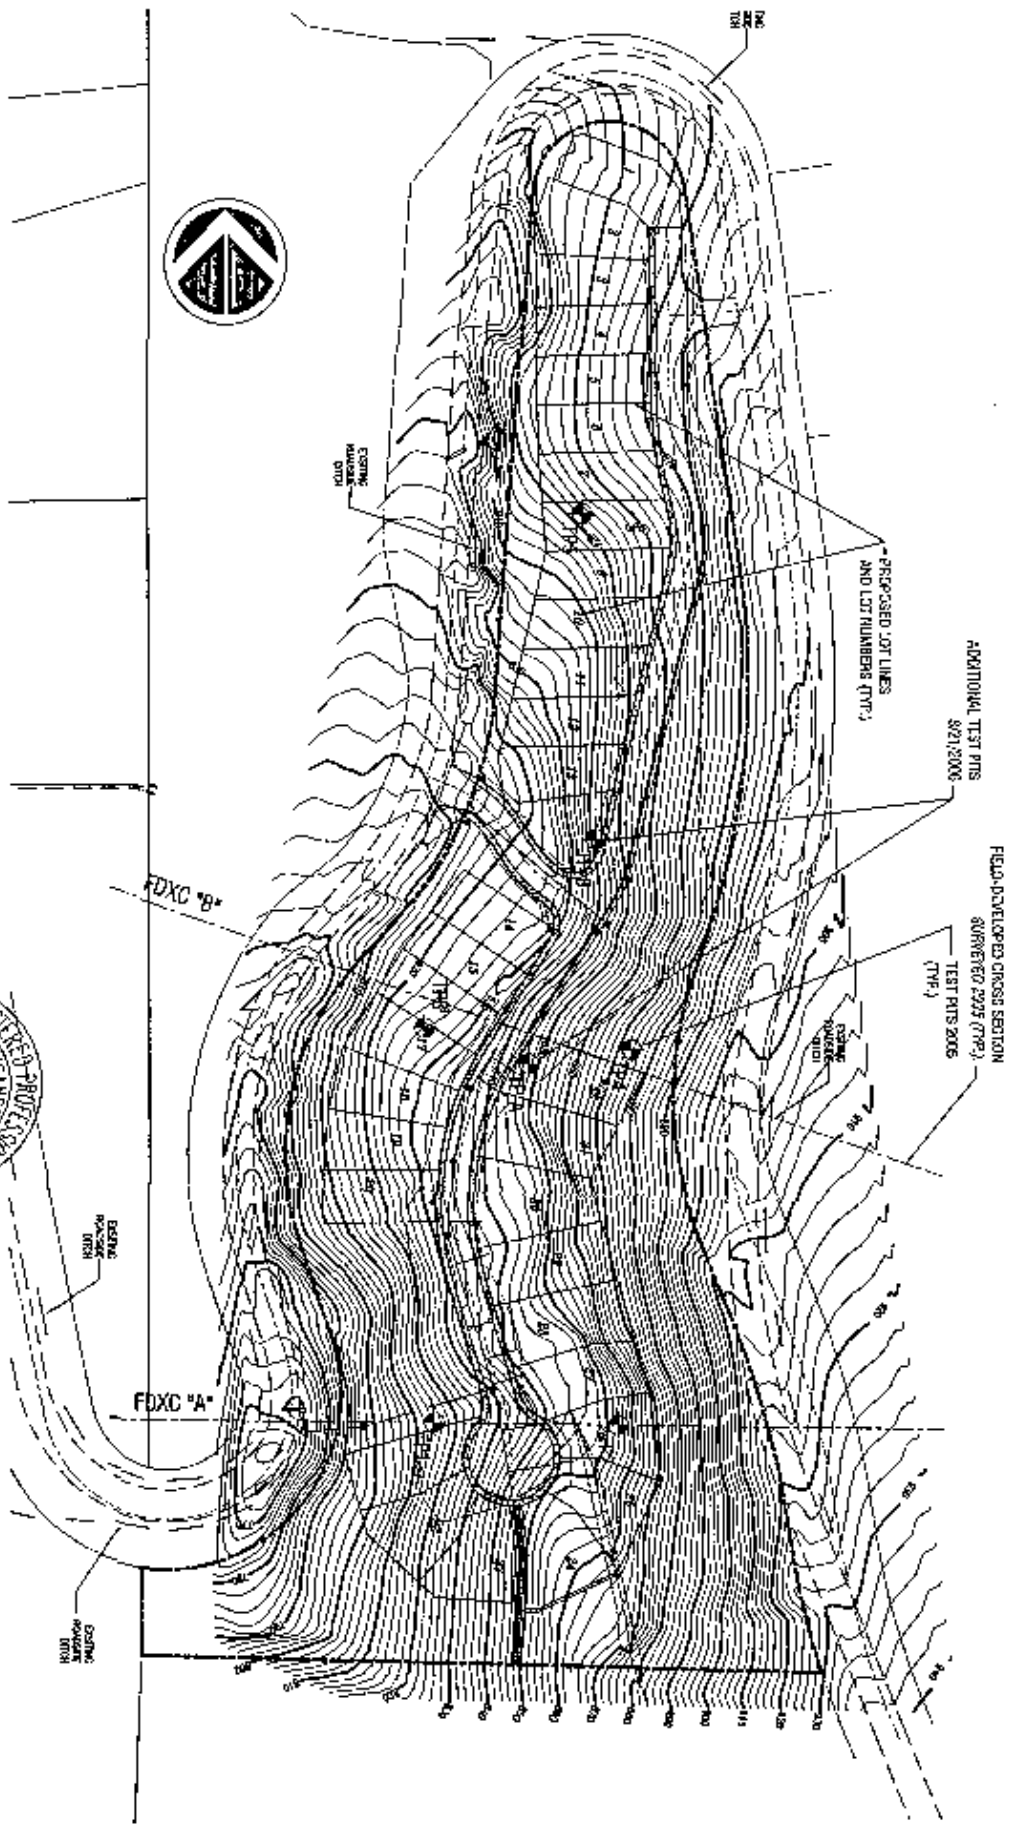
# GEOTECHNICAL SITE PLAN

These test pits, identified as test pit "TP-A" and "TP-B" are shown on the attached Geotechnical Site Plan. The test pits from our original geotechnical investigation in 2005 are also shown on this plan.

Soils in test pit "TP-A" consisted of 1.3-feet of brown, dry to damp, loose to moderately stiff organic SILT over tan/orange, dry to damp, highly weathered SANDSTONE. The test pit was excavated to a depth of 4.6-feet. No groundwater was encountered in the test pit.

Soils in test pit "TP-B" consisted of 2.2-feet of brown, dry to damp, loose to moderately stiff organic SILT over tan/olive, dry to damp, decomposed tuffaceous SANDSTONE with included subrounded cobbles and boulders to 15-inches. The test pit was excavated to a depth of 5.0-feet. No groundwater was encountered in the test pit.
